Incident Alert

Excavator Tip Over

IA-02 9/08/2018 Issued by:	Grant Forsyth, Inframax Health & Safety Manager
For more info please call:	Grant Forsyth; 027 535 4293
ICL-HLS-FRM-025	Version 1 May 2018

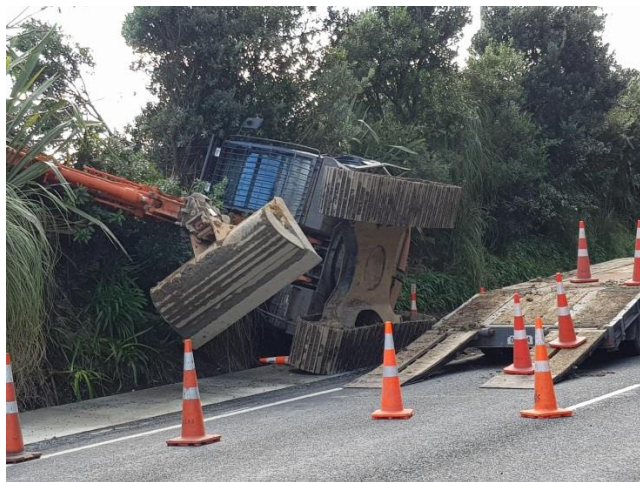
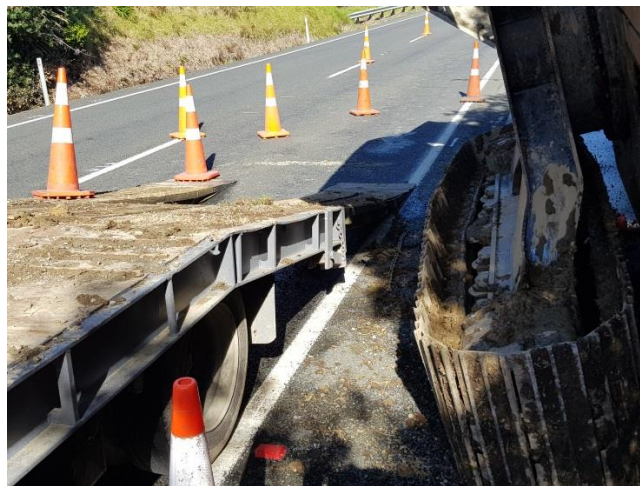
On Monday 6th Aug, a contractor was unloading a 13-ton excavator from a transport trailer when it slipped sideways off the trailer at the top of the ramp, and tip onto its side.

ROOT CAUSE	DIRECT CAUSES	CONTRIBUTING FACTORS
<ul style="list-style-type: none"> Insufficient risk assessment and control of the unloading activity. I.e. a pre task walk around risk check and discussion of required mitigation measures did not occur prior to commencing the off-loading task. 	<ul style="list-style-type: none"> Trailer was parked on a 9.9 degree sideways slope, which was too steep to safely unload the excavator The rear 1.8m meters of the deck up to the hinge point of the ramp was steel providing insufficient friction between the deck and the excavator tracks 	<ul style="list-style-type: none"> Inadequate formal operator training and competency assessment for transporting and handling machinery. <i>This is an industry wide issue as there is no training or competency standard for this task.</i> Stabilising feet located at the end of the beaver tail on the trailer were not engaged Wet and dirty surfaces on the transporter deck and excavator tracks A spotter was not in place to observe and assist the unloading process

- Undertake a pre-task walk around risk check before unloading any machinery.
- Look into a level indicator that can be mounted onto the tail of transport trailers and create a limit that a trailer can be at to unload.
- Create an in-house training program that will draw on the vast knowledge from a forum of the most experienced operators.
