**Incident Title:**

Underground Consumer Electrical Cable Struck By Grundomat

Date of Incident Alert issue: 09 July 2018

Alert Number: 180709

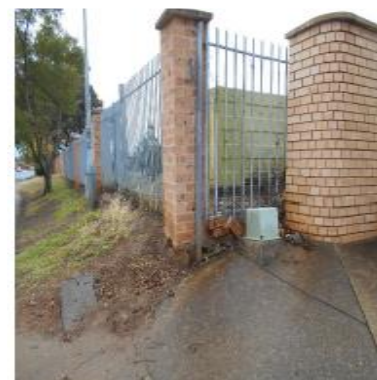
Photo (1a): Work area showing electrical pillar and padmount station

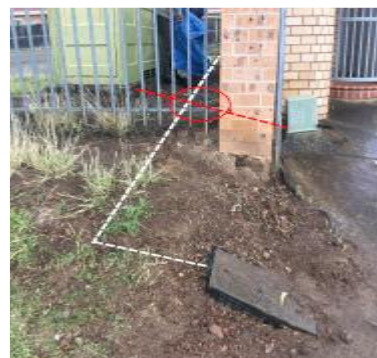
Photo (1b): Section where grundomat operated

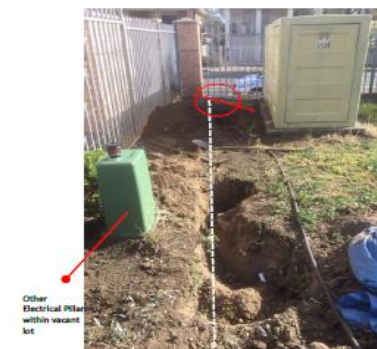
Photo (1c): The path that the Grundomat took
