# Safety Alert

## Roller Tip Over

<b>SA-06</b> Issued by:	Grant Forsyth, Inframax Health & Safety Manager
For more info please call:	Grant Forsyth; 027 535 9243

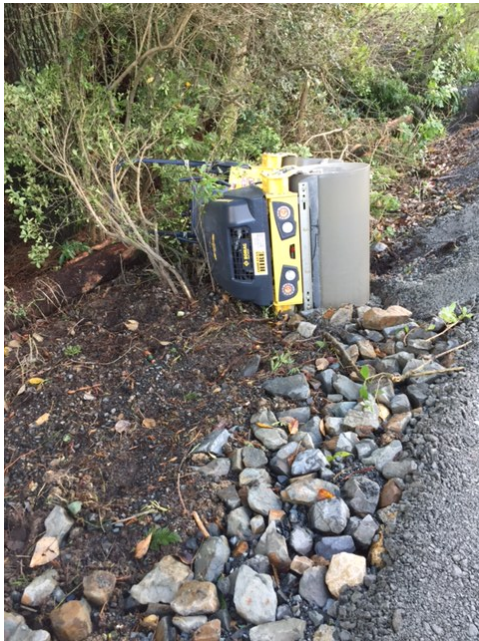
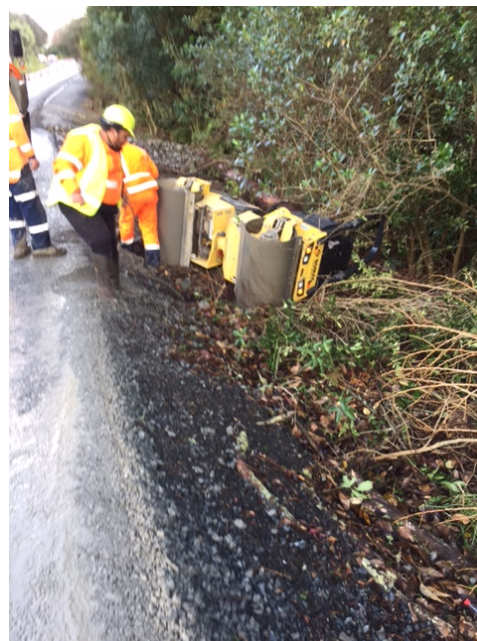
On Wednesday 11<sup>th</sup> July 2018 we had a 1.5 ton hire roller slide off the shoulder and tip onto its side – thankfully the operator was wearing his seatbelt so he was not injured.

This is the second roller tip over in the last 9 months, and the similar contributing factors; operator inattention, operating too close to the hinge point of the shoulder, working beside a drop off not being recognised as high risk.

- ✓ Make sure you fully check the area for any risks of drop offs before starting any work
- ✓ Ensure there is at least a 500mm gap between the roller and the hinge point of the shoulder
- ✓ Vibration is not used when rolling next to the hinge point where there is a drop off
- ✓ You are familiar with the equipment you are operating
- ✓ Walk the site to determine areas of risk operating equipment on the shoulders, always complete a pre-start risk assessment
